Front seat backrest trim protrudes

Topic number LI91.10-P-055704

Design group 91.10 Front seats

Validity Model series 207 and 204.3

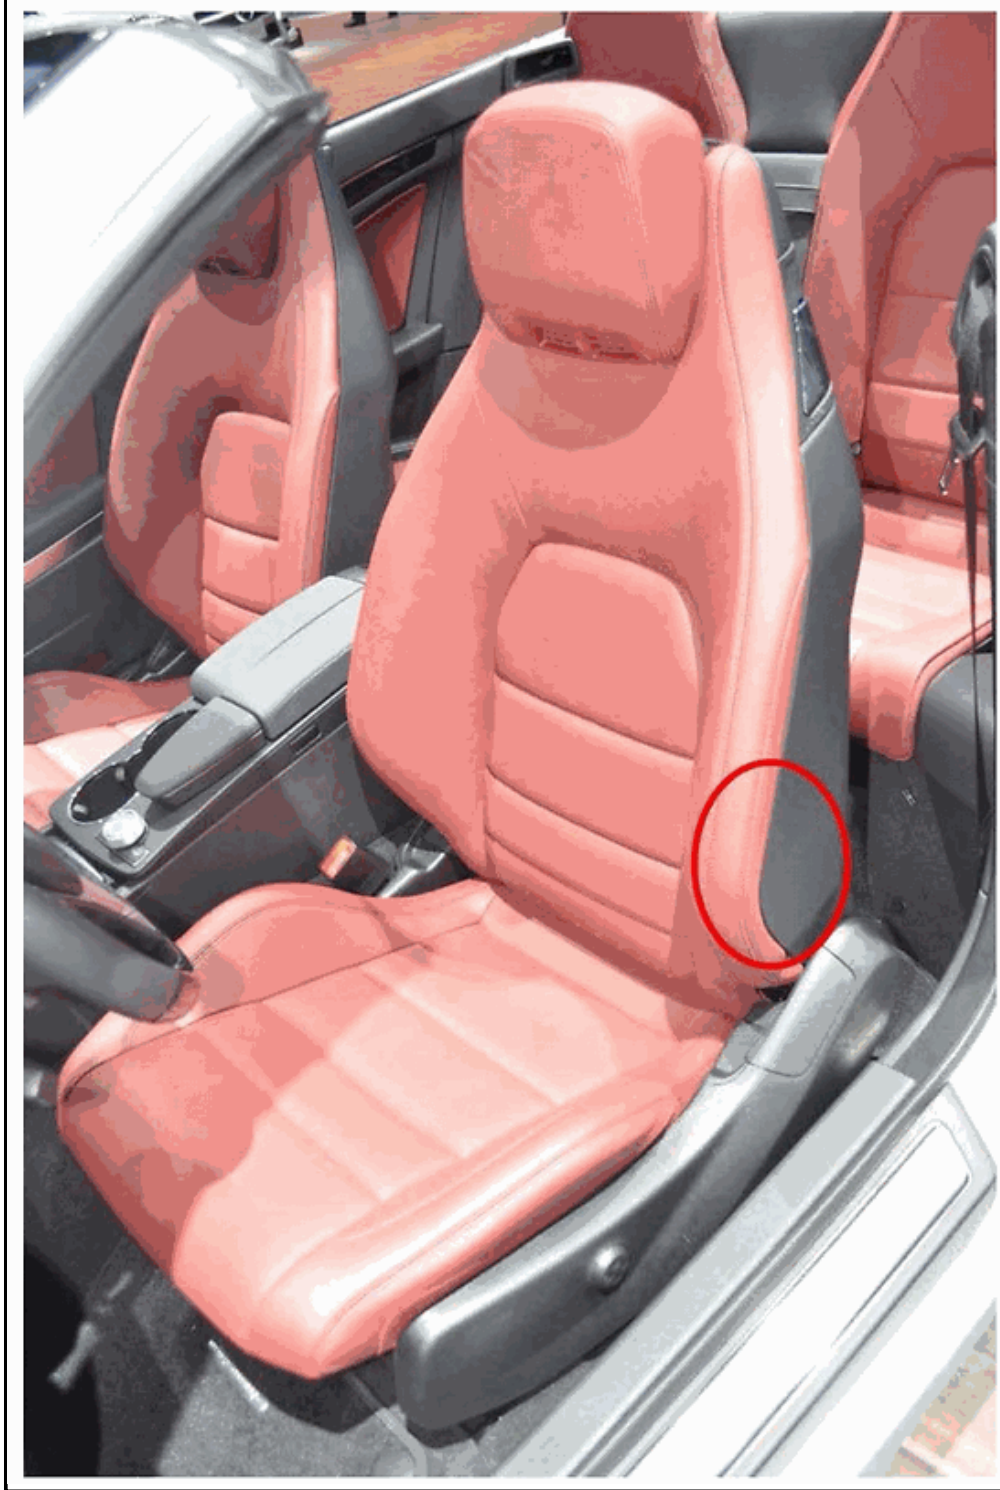
Gap forming between backrest cover frame and backrest padding in area of side bolster, trim protrudes (for area see Pic0).

File	Designation
Pic0.jpg	Area of gap formation Picture shows OK condition

Cause:
Mounting clip loosening under load.
