Noises from area of firewall/instrument panel in S/W 204

Topic number LI62.25-P-056363
 Version 1
 Design group 62.25 Fire wall
 Date 06-07-2013
 Validity Affected vehicles
 S/W from VIN 204 G109570 to 204 G124323

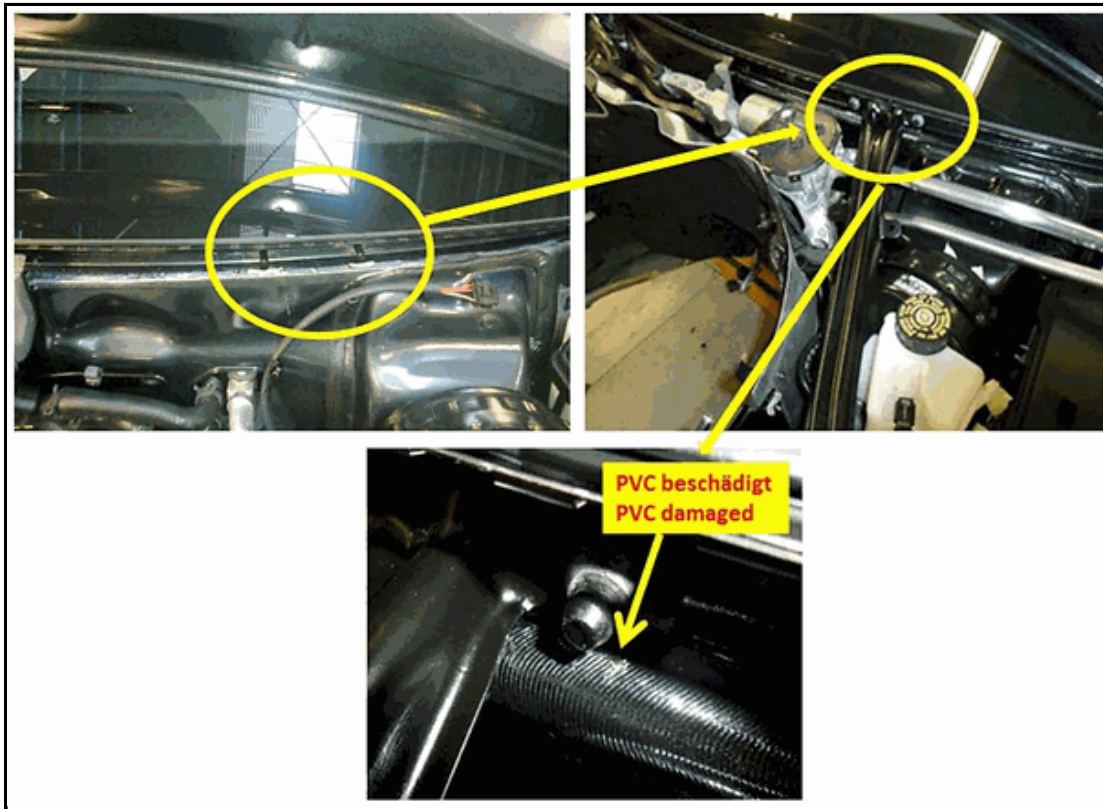
File	Designation
Schadensbereich.jpg	Firewall under windsheild

Noises from area of firewall/instrument panel.

The left front X-strut from the strut tower to the firewall may be touching the PVC seam and causing noises.

- Remove cover of windshield wiper linkage under windshield.
- Detach X-strut.
- Rework PVC seam, if necessary bending the two flat bolts upwards slightly.
- Then restore the corrosion protection per WIS.
