XENTRY TIPS

Throttle lift-off clunking noise from side shaft

Topic number	LI35.30-P-058566
Version	4
Design group	35.30 Final drive, drive shafts
Date	08-17-2016
Validity	Model 171,203,204,205,207,209,211,212,215,216,217,218,219,220,221,222,230,231 Models 203, 209, 171 as of approx. week 21/04 coated as standard with Molykote paint
Reason for change	Validity for new model series updated.

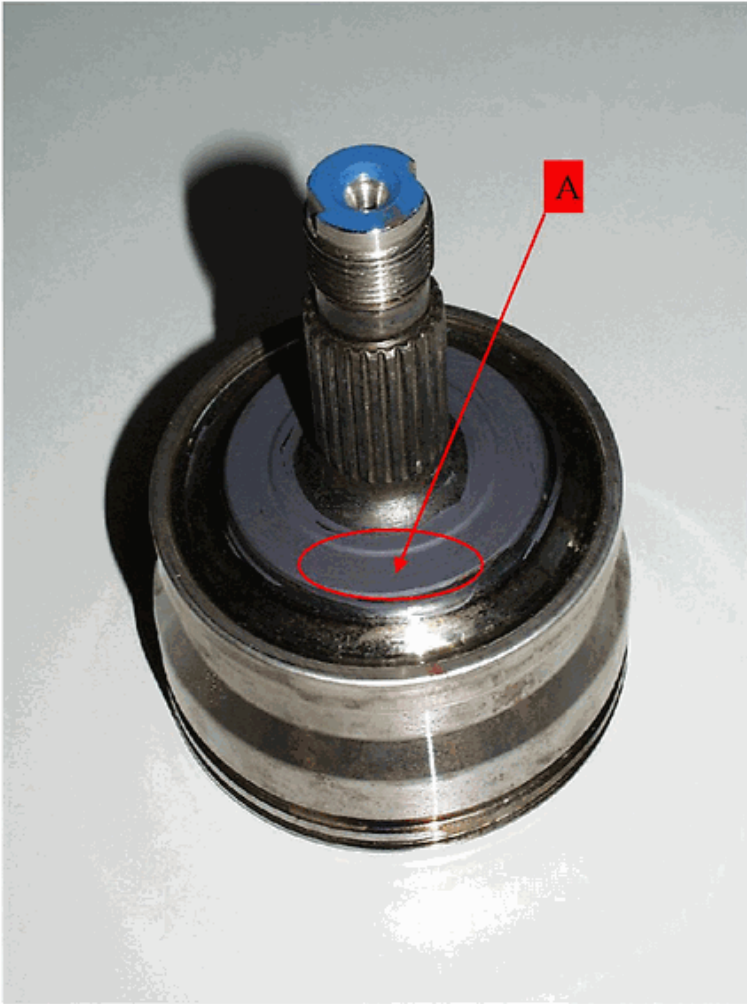
Attachments	
File	Description
Gelenkgehäuse aussen vor.jpg	Before coating with Molykote paint

Single throttle lift-off clunking noise from the side shaft when moving off (audible at the outboard end). Noise is heard once when changing direction of travel.

If the complaint is eliminated by experimentally loosening the outboard collar nut (by 1 turn), the complaint may be due to cracking of the microweld between the wheel bearing inner race and the joint housing of the side shaft.

Coat contact surface of side shaft with wheel bearing with Molykote paint. To do this, proceed as follows:

1. Remove side shafts
2. Clean contact surface A (see image file in attachment "Outer joint housing before") before coating with Molykote paint (free of dust and grease)
3. Coat contact surface A (see image file in attachment "Outer joint housing after") with Molykote and leave to dry for "one hour" in removed condition
4. Reinstall side shafts
