SI B61 20 14
General Electrical Systems

SUBJECT
Vehicle Only Starts when Remote Key Held Against Column

MODEL
F30 (3 Series Sedan)

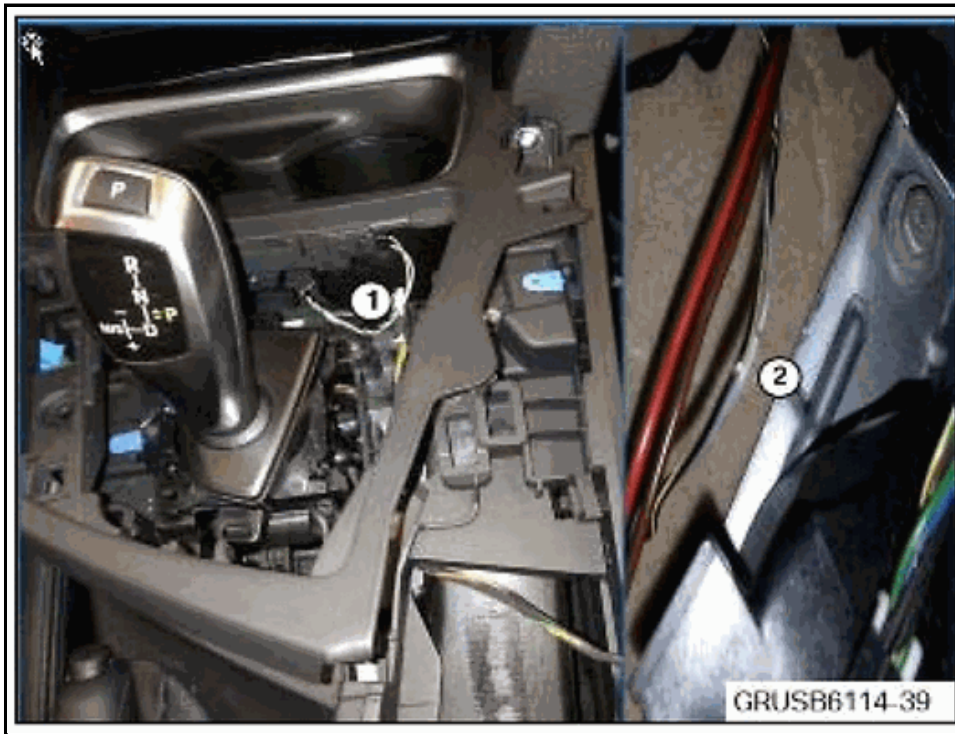
CAUSE
The antenna (aerial) in the passenger compartment near the front of the center console has shorted wiring.

3. Remove the center console trim cover and gain access to the aerial wiring (1).

4. The wiring harness gets shorted against the metal bracket (2).

(2) is a close-up of the area indicated in (1).

5. Repair the wiring harness. Position the harness away from the metal bracket.
